MANAGEMENT REPORT

ESTES EXPRESS LINES - HQ
YRC Inc. Kearny, NJ
72 Second Street
Kearny, NJ 07032

SITE OVERVIEW

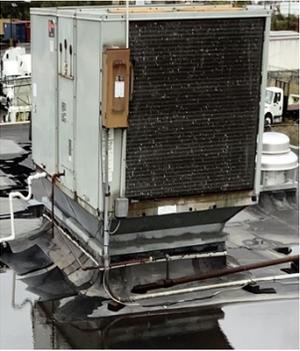
1

<p>NAME: CURB FLASHING FAILURE (EMERGENCY) QUANTITY: 1.0 EA</p> <p>DEFICIENCY The existing roof top curb flashing has failed and is allowing water to enter the roof system.</p> <p>CORRECTIVE ACTION Remove the existing flashing, as needed. Provide and install new flashings with compatible materials according to the manufacturer's specifications.</p> <p>PROJECTED CONSEQUENCES IF NOT CORRECTED Curb flashings are required to endure expansion caused by movement in the deck, mechanical equipment and other forces. They are also often damaged by people, birds, animals and insects. Regular inspection of curbs with a PM program is recommended.</p>

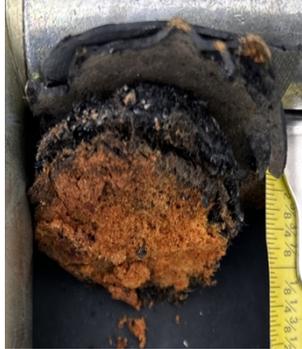
2

NAME: INSULATION REPLACEMENT (EMERGENCY)
QUANTITY: 1.0 EA

DEFICIENCY
The existing insulation is either wet, damaged or missing and in need of replacement.

PROJECTED CONSEQUENCES IF NOT CORRECTED
Wet insulation acts as a conductor rather than as an effective thermal barrier. It can sustain bacterial growth under the membrane and cause the deck, fasteners or plates to weaken due to rust.

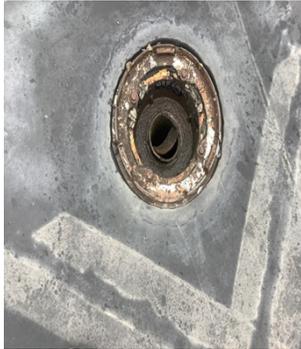
1

<p>NAME: REPLACE DRAINS (EMERGENCY) QUANTITY: 12.0 EA</p> <p>DEFICIENCY The drains need to be replaced with new inserts.</p> <p>CORRECTIVE ACTION Install (12) new drain inserts during roof replacement project.</p> <p>PROJECTED CONSEQUENCES IF NOT CORRECTED Gutters provide a finished look and perform an important function to manage the flow of water off a home or building.</p>

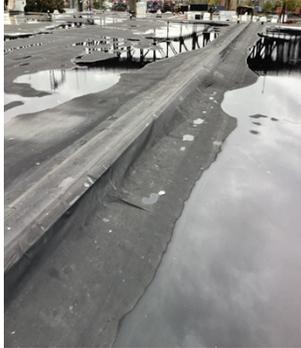
2

<p>NAME: MEMBRANE BECOMING UNADHERED (EMERGENCY) QUANTITY: 101.0 LF</p> <p>DEFICIENCY The membrane is becoming adhered from the wall / expansion joint.</p> <p>CORRECTIVE ACTION Replace roof system.</p> <p>PROJECTED CONSEQUENCES IF NOT CORRECTED Delamination of the membrane exposes the scrim reinforcement, significantly reducing the integrity of the roofing system, accelerating its aging process and decreasing the service life of the roof.</p>

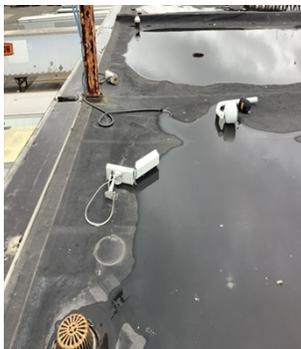
3

NAME: DEBRIS (EMERGENCY)

QUANTITY: 5.0 EA

DEFICIENCY

Debris on the roof can cause damage by causing punctures and/or tears in the membrane.

Remove and properly disposed of loose debris per bag.

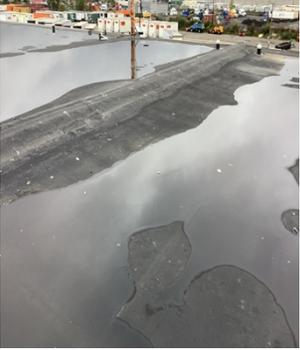
1

<p>NAME: MEMBRANE BECOMING UNADHERED (EMERGENCY) QUANTITY: 202.0 LF</p> <p>DEFICIENCY The membrane is becoming unadhered at the wall / expansion joint.</p> <p>CORRECTIVE ACTION Replace roof system.</p> <p>PROJECTED CONSEQUENCES IF NOT CORRECTED Delamination of the membrane exposes the scrim reinforcement, significantly reducing the integrity of the roofing system, accelerating its aging process and decreasing the service life of the roof.</p>

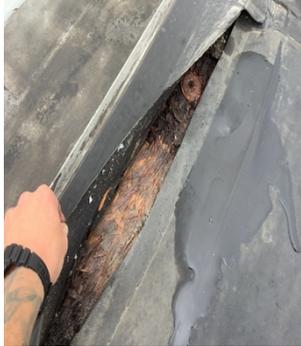
2</p>

<p>NAME: EDGE METAL FLASHING FAILURE / REPLACEMENT (EMERGENCY) QUANTITY: 170.0 LF</p> <p>DEFICIENCY The existing edge metal has been damaged or failed and is in need of replacement.</p> <p>CORRECTIVE ACTION Install new edge metal and flash per manufacturer's specifications during roof replacement project.</p> <p>PROJECTED CONSEQUENCES IF NOT CORRECTED Damaged or missing gravel stops negatively impact the looks of a building and can be a major source of leaks at the perimeter of the building. Gravel stops must be securely installed to protect against high winds.</p>
--	---	--

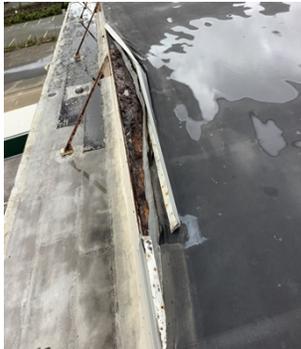
1

<p>NAME: EDGE METAL FLASHING FAILURE / REPLACEMENT (EMERGENCY) QUANTITY: 390.0 LF</p> <p>DEFICIENCY The existing edge metal has been damaged or failed and is in need of replacement.</p> <p>CORRECTIVE ACTION Install new edge metal per manufacturer's specifications during roof replacement project.</p> <p>PROJECTED CONSEQUENCES IF NOT CORRECTED Damaged or missing gravel stops negatively impact the looks of a building and can be a major source of leaks at the perimeter of the building. Gravel stops must be securely installed to protect against high winds.</p>

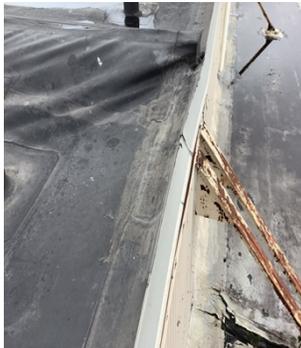
2</p>

<p>NAME: MEMBRANE BECOMING UNADHERED (EMERGENCY) QUANTITY: 101.0 LF</p> <p>DEFICIENCY The membrane is becoming unadhered at the wall / expansion joint.</p> <p>CORRECTIVE ACTION Replace roof system.</p> <p>PROJECTED CONSEQUENCES IF NOT CORRECTED Delamination of the membrane exposes the scrim reinforcement, significantly reducing the integrity of the roofing system, accelerating its aging process and decreasing the service life of the roof.</p>
--	---	---

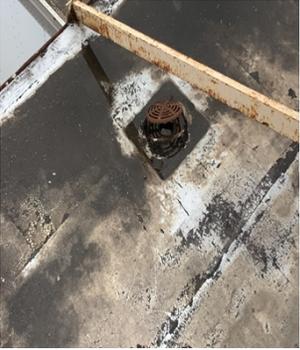
1

<p>NAME: BROKEN DRAIN (8" OR LESS) (EMERGENCY) QUANTITY: 6.0 EA</p> <p>DEFICIENCY Repalce with a retrofit drain.</p> <p>CORRECTIVE ACTION Provide and install new retrofit drain with target patch during roof replacement project.</p> <p>PROJECTED CONSEQUENCES IF NOT CORRECTED A broken drain ring can result in minor leaks or a major flooding of a building due to water being directed to it for removal from the building.</p>

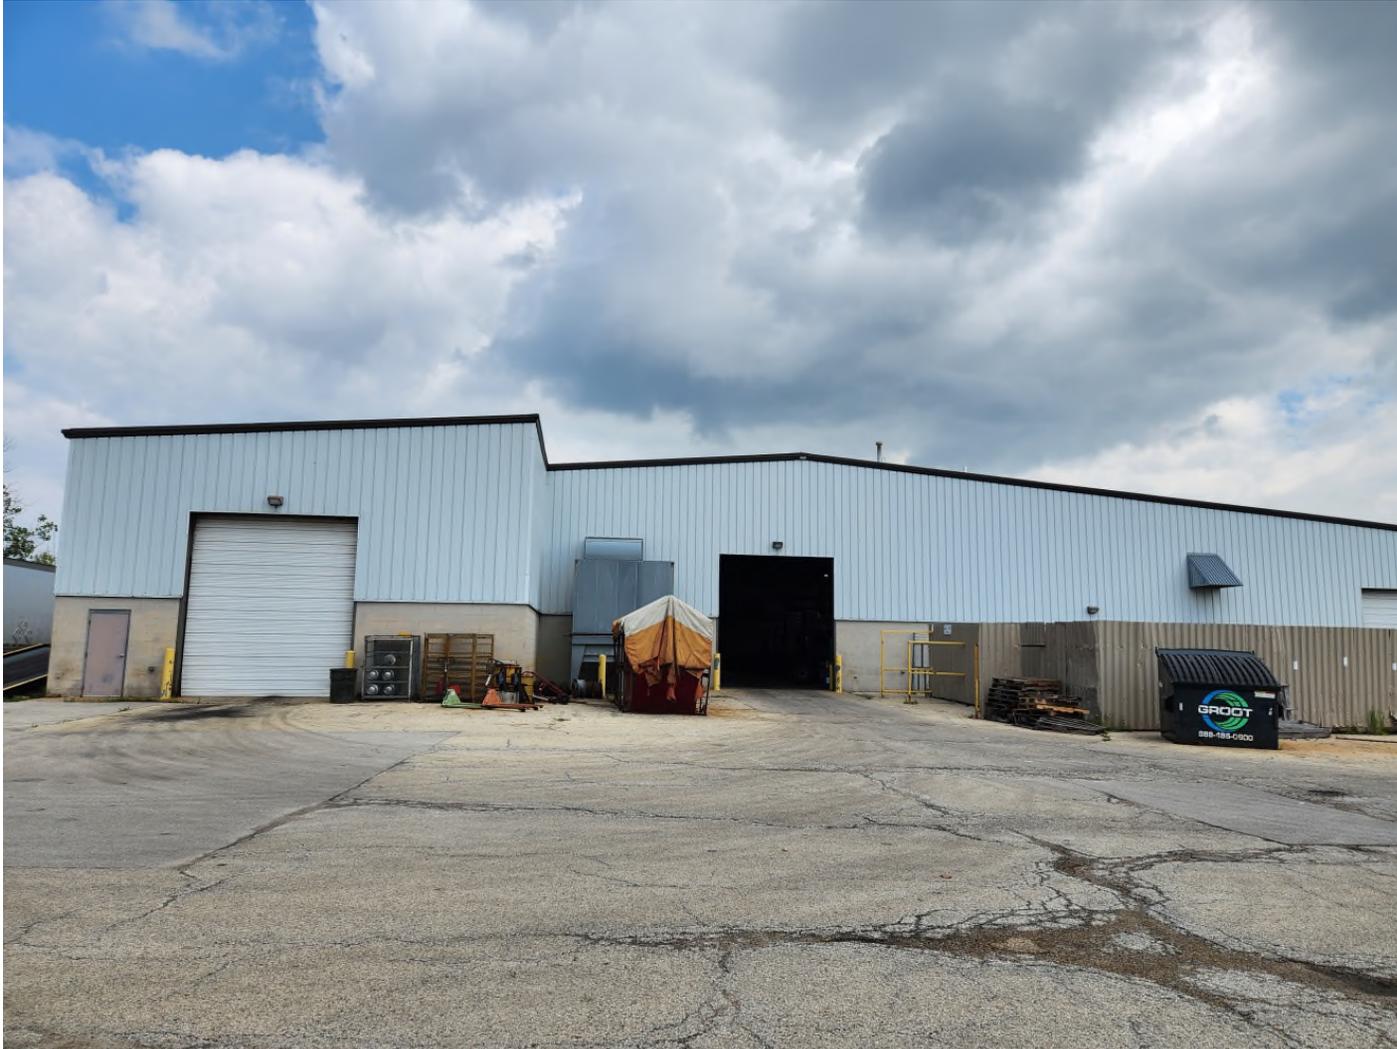
EXHIBIT D

6. Additionally, Estes discovered severe damage to many of the Properties' asphalt parking areas. A representative photograph of the damaged parking area at the Property located in Joliet, Illinois, is attached as **Exhibit D**. The cost of repairing these parking areas will be significant. Estes estimates that the cost of repairing the damage to the asphalt in Joliet will cost nearly \$3 million. See **Exhibit E-1**. The Property located in South Bend, Indiana similarly will require approximately \$2.9 million in repairs to its parking surfaces. See **Exhibit E-3**. Parking areas at several other properties also require maintenance that will cost in excess of \$1 million each.

Asphalt Damage, Joliet, Indiana

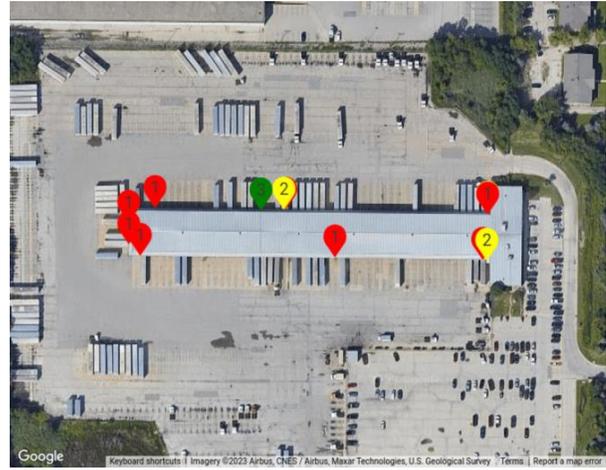
Section: 2-Section Two
Size: 8,515
Overall Grade: B
Inspection Date: 10/12/2023
Inspector: Ted Huven

Recommendations: Repair - This roof section is in fair overall condition for its age/composition and is only in need of minor maintenance/repair currently. With continued monitoring and maintenance, we'd expect this section to meet or exceed its manufacturers estimated life expectancy. Therefore, we recommend the outlined repairs be performed and this time that this section continue to be monitored and maintained on an annual basis to maximize its life expectancy.

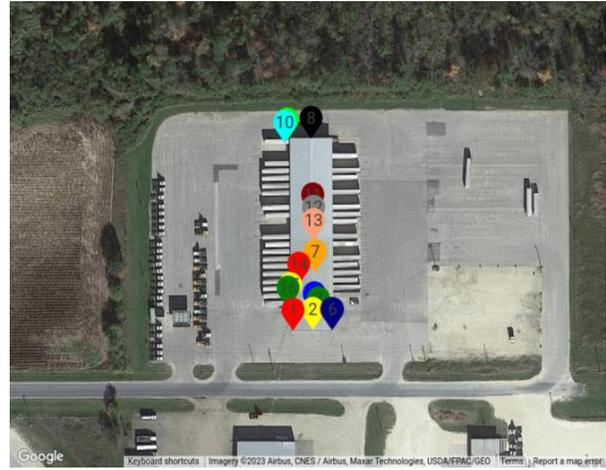
Section: 1-Section One
Size: 21,306
Overall Grade: B
Inspection Date: 10/09/2023
Inspector: Ted Huven

Recommendations: Repair - This roof section is in good overall condition for its age/composition and is only in need of minor maintenance/repair currently. With continued monitoring and maintenance, we'd expect this section to meet or exceed its manufacturers estimated life expectancy. Therefore, we recommend the outlined repairs be performed and this time and that this section continue to be monitored and maintained on an annual basis to maximize its life expectancy.
