**IN THE UNITED STATES BANKRUPTCY COURT
FOR THE DISTRICT OF DELAWARE**

**OBJECTION AND RESERVATION OF RIGHTS
TO THE DEBTORS' NOTICE OF POTENTIAL ASSUMPTION OR
ASSUMPTION AND ASSIGNMENT OF CERTAIN CONTRACTS
OR LEASES ASSOCIATED WITH THE NON-ROLLING STOCK ASSETS**

MANAGEMENT REPORT

YRC Inc. Kearny, NJ
72 Second Street
Kearny, NJ 07032

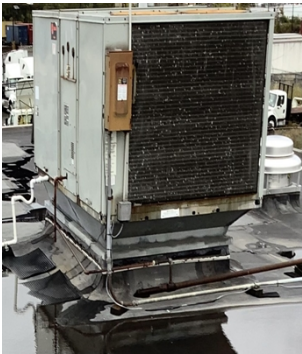
1

<p>NAME: CURB FLASHING FAILURE (EMERGENCY) QUANTITY: 1.0 EA</p> <p>DEFICIENCY The existing roof top curb flashing has failed and is allowing water to enter the roof system.</p> <p>CORRECTIVE ACTION Remove the existing flashing, as needed. Provide and install new flashings with compatible materials according to the manufacturer's specifications.</p> <p>PROJECTED CONSEQUENCES IF NOT CORRECTED Curb flashings are required to endure expansion caused by movement in the deck, mechanical equipment and other forces. They are also often damaged by people, birds, animals and insects. Regular inspection of curbs with a PM program is recommended.</p>

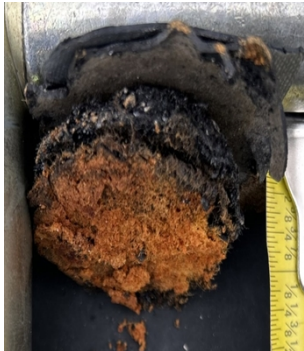
<p>2</p>

<p>NAME: INSULATION REPLACEMENT (EMERGENCY) QUANTITY: 1.0 EA</p> <p>DEFICIENCY The existing insulation is either wet, damaged or missing and in need of replacement.</p> <p>CORRECTIVE ACTION New insulation same in type and thickness will be installed to match existing.</p> <p>PROJECTED CONSEQUENCES IF NOT CORRECTED Wet insulation acts as a conductor rather than as an effective thermal barrier. It can sustain bacterial growth under the membrane and cause the deck, fasteners or plates to weaken due to rust.</p>
----------	---	--

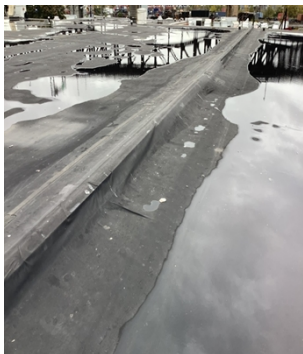
2

<p>NAME: MEMBRANE BECOMING UNADHERED (EMERGENCY) QUANTITY: 101.0 LF</p> <p>DEFICIENCY The membrane is becoming adhered from the wall / expansion joint.</p> <p>CORRECTIVE ACTION Replace roof system.</p> <p>PROJECTED CONSEQUENCES IF NOT CORRECTED Delamination of the membrane exposes the scrim reinforcement, significantly reducing the integrity of the roofing system, accelerating its aging process and decreasing the service life of the roof.</p>

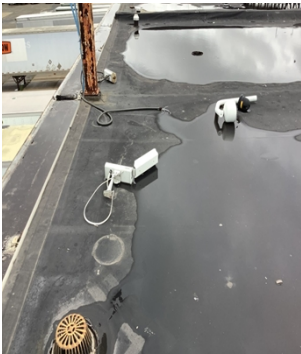
3</p>

<p>NAME: DEBRIS (EMERGENCY) QUANTITY: 5.0 EA</p> <p>DEFICIENCY Debris on the roof can cause damage by causing punctures and/or tears in the membrane.</p> <p>CORRECTIVE ACTION Remove and properly disposed of loose debris per bag.</p> <p>PROJECTED CONSEQUENCES IF NOT CORRECTED Debris left on the roof by others, animals or trees can lead to clogged drain systems and ponding water that can exceed design limits on the roof. Regularly remove debris from the roof to keep it safe and functional.</p>
--	---	---

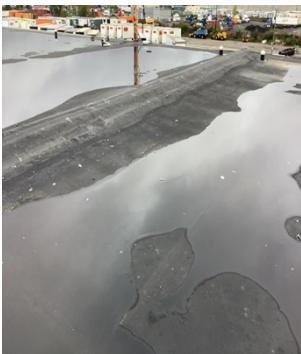
1

<p>NAME: MEMBRANE BECOMING UNADHERED (EMERGENCY) QUANTITY: 202.0 LF</p> <p>DEFICIENCY The membrane is becoming unadhered at the wall / expansion joint.</p> <p>CORRECTIVE ACTION Replace roof system.</p> <p>PROJECTED CONSEQUENCES IF NOT CORRECTED Delamination of the membrane exposes the scrim reinforcement, significantly reducing the integrity of the roofing system, accelerating its aging process and decreasing the service life of the roof.</p>

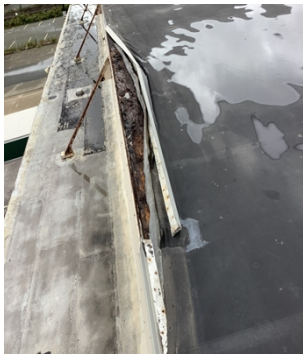
1

<p>NAME: EDGE METAL FLASHING FAILURE / REPLACEMENT (EMERGENCY) QUANTITY: 390.0 LF</p> <p>DEFICIENCY The existing edge metal has been damaged or failed and is in need of replacement.</p> <p>CORRECTIVE ACTION Install new edge metal per manufacturer's specifications during roof replacement project.</p> <p>PROJECTED CONSEQUENCES IF NOT CORRECTED Damaged or missing gravel stops negatively impact the looks of a building and can be a major source of leaks at the perimeter of the building. Gravel stops must be securely installed to protect against high winds.</p>

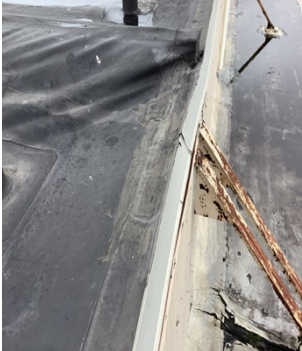
2</p>

<p>NAME: MEMBRANE BECOMING UNADHERED (EMERGENCY) QUANTITY: 101.0 LF</p> <p>DEFICIENCY The membrane is becoming unadhered at the wall / expansion joint.</p> <p>CORRECTIVE ACTION Replace roof system.</p> <p>PROJECTED CONSEQUENCES IF NOT CORRECTED Delamination of the membrane exposes the scrim reinforcement, significantly reducing the integrity of the roofing system, accelerating its aging process and decreasing the service life of the roof.</p>
--	---	---

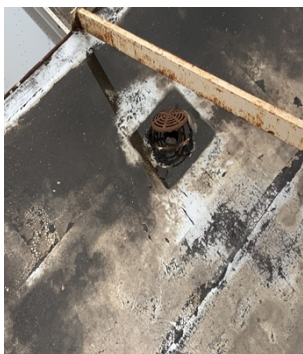
1

<p>NAME: BROKEN DRAIN (8" OR LESS) (EMERGENCY) QUANTITY: 6.0 EA</p> <p>DEFICIENCY Repalce with a retrofit drain.</p> <p>CORRECTIVE ACTION Provide and install new retrofit drain with target patch during roof replacement project.</p> <p>PROJECTED CONSEQUENCES IF NOT CORRECTED A broken drain ring can result in minor leaks or a major flooding of a building due to water being directed to it for removal from the building.</p>

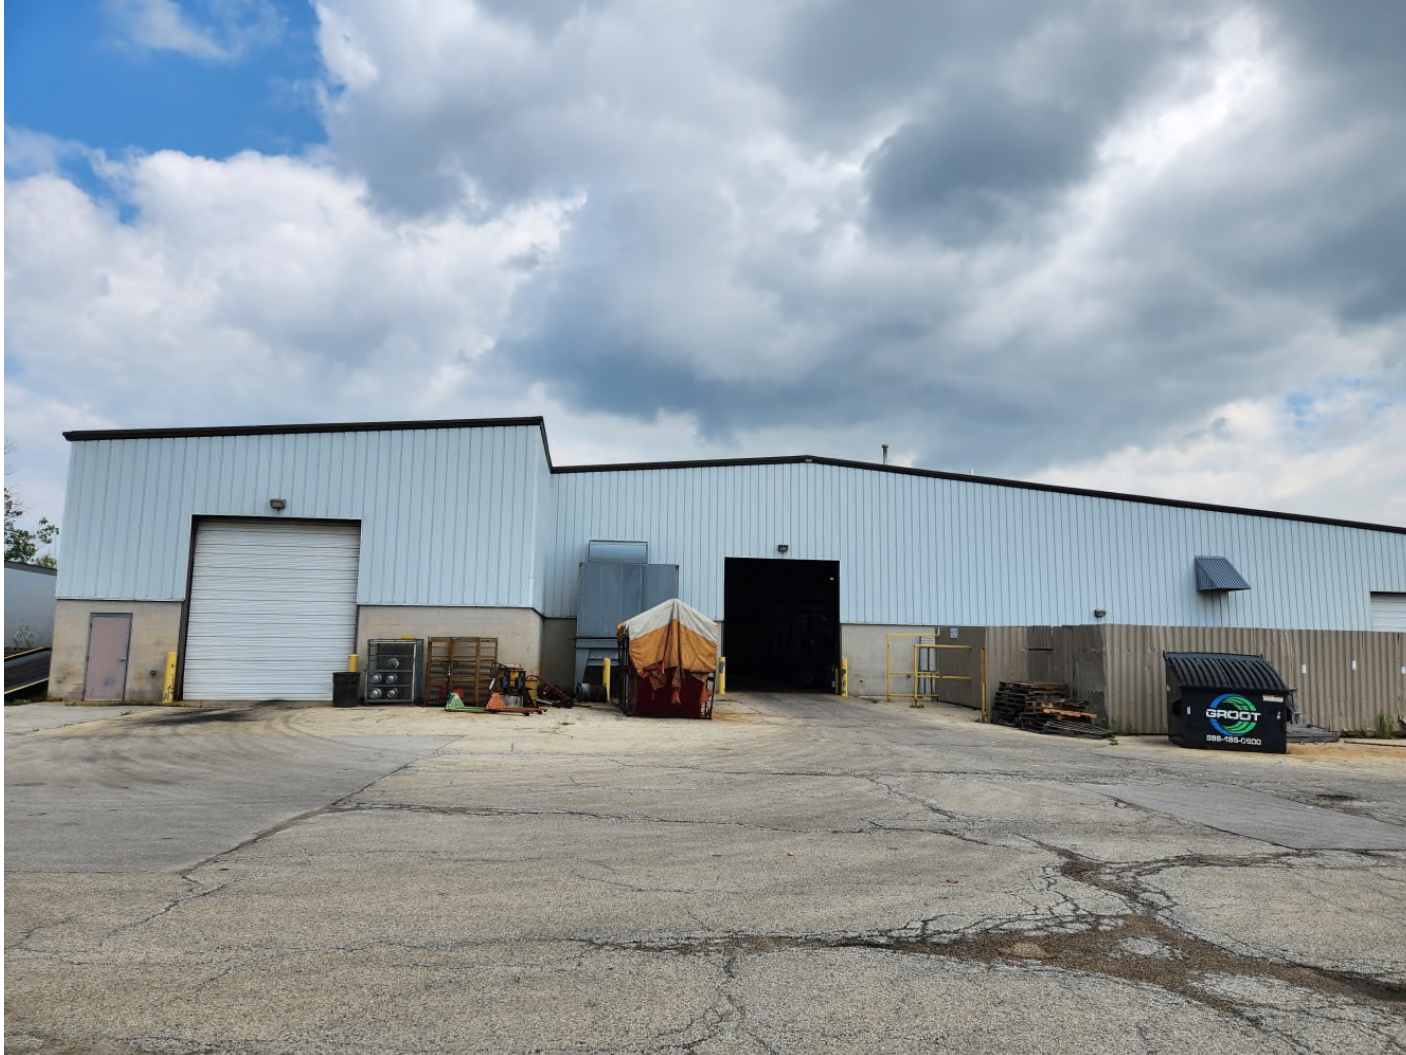
Asphalt Damage, Joliet, Indiana

6. Additionally, Estes discovered severe damage to many of the Properties' asphalt parking areas. A representative photograph of the damaged parking area at the Property located in Joliet, Illinois, is attached as **Exhibit D**. The cost of repairing these parking areas will be significant. Estes estimates that the cost of repairing the damage to the asphalt in Joliet will cost nearly \$3 million. See **Exhibit E-1**. The Property located in South Bend, Indiana similarly will require approximately \$2.9 million in repairs to its parking surfaces. See **Exhibit E-3**. Parking areas at several other properties also require maintenance that will cost in excess of \$1 million each.

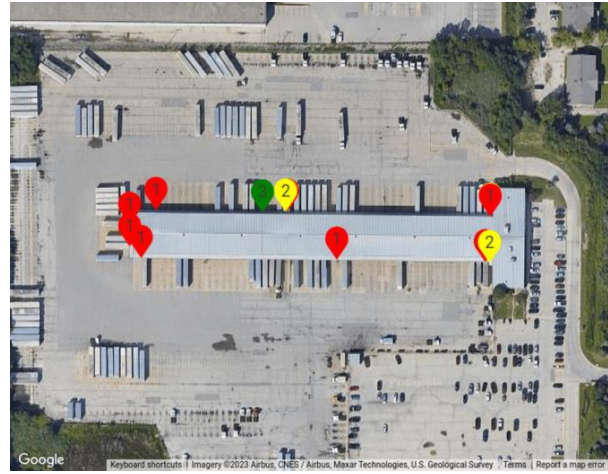
Section: 2-Section Two
Size: 8,515
Overall Grade: B
Inspection Date: 10/12/2023
Inspector: Ted Huven

Areas	Rating	Deficiency	Corrective Action	Consequences
Gutters and Downspouts	B	Most gutters and downspouts appear to be in satisfactory condition. Minor concerns include cosmetic damage due to dents, attachment or debris that may impede the flow of water off the roof		Keeping the gutters and downspouts clean and free of debris enhances the flow of water off the roof. Small clean up or repairs may be required.
Expansion / Control Joints	B	There is minor damage to the expansion/control joint cover and/or may require caulking at panel joints although it does not appear to impact the integrity of the roof.	Repair the expansion/control joint cover with like materials and provide commercial grade sealants as required.	This detail allows for structural movement in the building and the cover needs to remain positively attached and sealed to keep water out of the building.

Recommendations: Repair - This roof section is in fair overall condition for its age/composition and is only in need of minor maintenance/repair currently. With continued monitoring and maintenance, we'd expect this section to meet or exceed its manufacturers estimated life expectancy. Therefore, we recommend the outlined repairs be performed and this time that this section continue to be monitored and maintained on an annual basis to maximize its life expectancy.

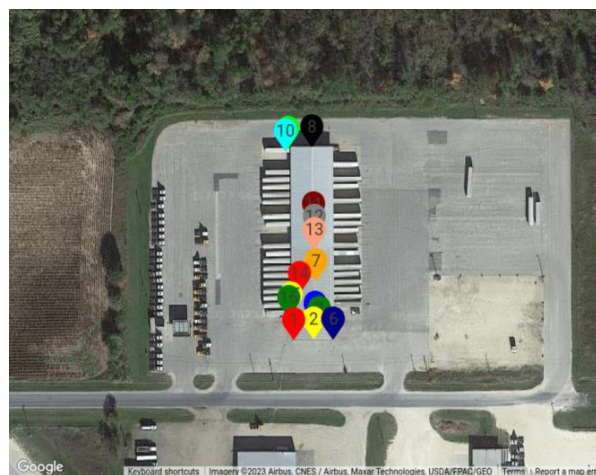
Section: 1-Section One
Size: 21,306
Overall Grade: B
Inspection Date: 10/09/2023
Inspector: Ted Huven

Areas	Rating	Deficiency	Corrective Action	Consequences
Penetration Pockets	B	The penetration pockets appear to be flashed properly, and are filled with an asphalt-based mastic or pourable sealer. Some of the penetration pockets need to be topped off with additional like materials.	Fill and top off the penetration pockets with like materials.	Penetration pockets typically allow for conduits, small piping or irregular shaped items that go through the roof to be secured and made watertight. They should be inspected regularly to ensure that they remain topped off to keep the roof watertight.

Recommendations: Repair - This roof section is in good overall condition for its age/composition and is only in need of minor maintenance/repair currently. With continued monitoring and maintenance, we'd expect this section to meet or exceed its manufacturers estimated life expectancy. Therefore, we recommend the outlined repairs be performed and this time and that this section continue to be monitored and maintained on an annual basis to maximize its life expectancy.
