MANAGEMENT REPORT

ESTES EXPRESS LINES - HQ
YRC Inc. Kearny, NJ
72 Second Street
Kearny, NJ 07032

SITE OVERVIEW

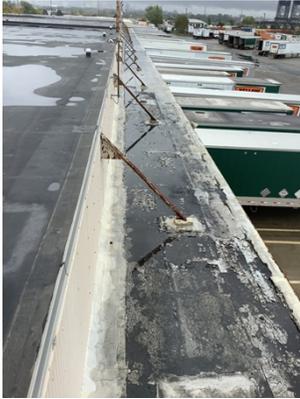
Section: Section 7
Size: 4,118
Overall Grade: F
Inspection Date: 10/23/2023
Inspector: Mark Repsher

<p>COMMENTS: Overview</p>

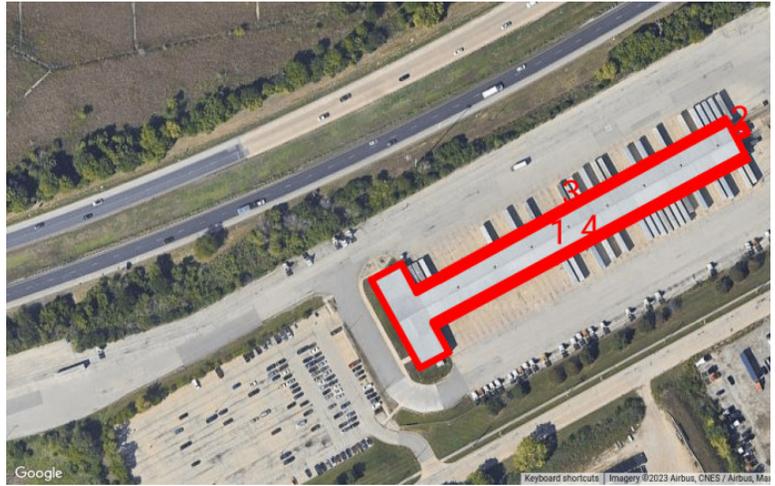
Holland Joliet, IL
3801 Mound Road
Joliet, IL 60431

Deficiency	Qty	Emergency	Remedial
Fastener Backing Out	300 EA	\$1,530.00	
Caulk application	20 EA	\$1,020.00	
Missing Fasteners on metal roofs	25 EA	\$128.00	
Pipe penetration failure	3 EA	\$1,530.00	
Gutter straps rusted	60 EA		\$1,510.00
Detached Panels	3 EA		\$0.00
Debris	200 LF	\$310.00	
Mobilization	1 EA	\$620.00	
Improper Repairs	12 EA	\$7,440.00	
Total		\$12,578.00	\$1,510.00
Section 1 - Main Roof Total: \$14,088.00

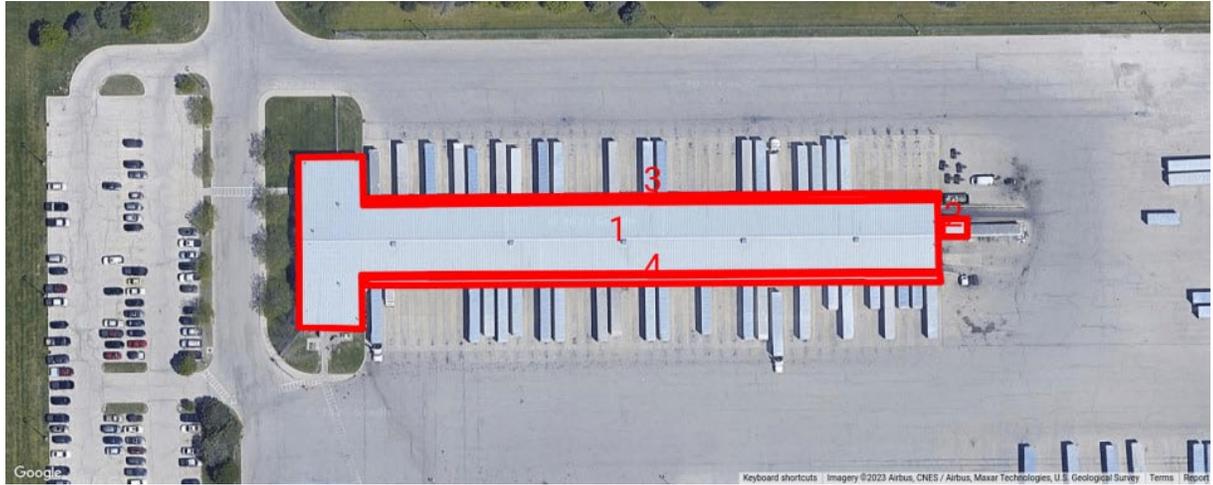
:
 Holland
 Rockford, IL
 1751 New
 Milford
 School Road
 Rockford, IL
 61109

Deficiency	Qty	Emergency	Remedial
Caulk application	3 EA	\$156.00	
Fastener Backing Out	350 EA	\$1,785.00	
Debris	200 EA	\$310.00	
Rust	25 EA		\$1,750.00
Pipe penetration failure	8 EA	\$4,080.00	
Mobilization	1 EA	\$710.00	
Total		\$7,041.00	\$1,750.00
Section 1 - Main Roof Total: \$8,791.00

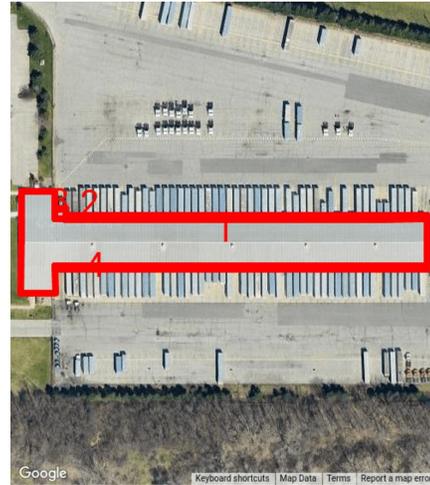
Holland South Bend, IN
 5550 Cleveland Road
 South Bend, IN 46628

Deficiency	Qty	Emergency	Remedial
Debris	50 LF		\$500.00
Total		\$0.00	\$500.00
Main section Total: \$500.00

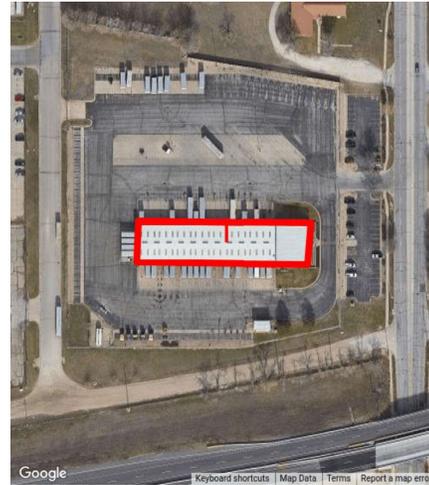
YRC Inc. Wichita, KS
 4931 South Hydraulic Avenue
 Wichita, KS 67216

Deficiency	Qty	Emergency	Remedial
Fastener Backing Out *	30 EA	\$1,095.00	
Fastener Failure	180 EA	\$2,250.00	
Vent pipe flashing	8 EA	\$1,075.00	
Caulk application	13 LF	\$0.00	
Fastener Backing Out	27 EA	\$0.00	
Caulk application *	30 EA	\$1,055.00	
Field-Punctures, cracks, splits	9 EA	\$1,175.00	
Caulk application	10 LF	\$0.00	
Total		\$6,650.00	\$0.00
Section 1 Total: \$6,650.00

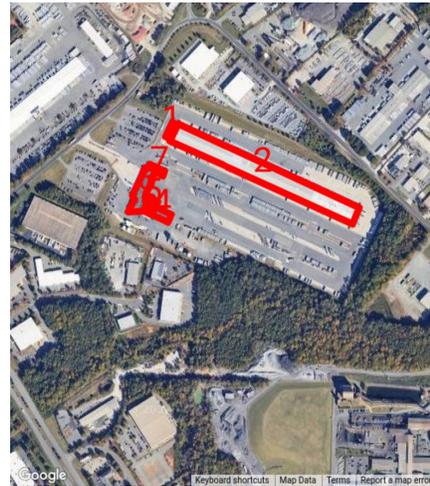
YRC Inc. Charlotte, NC
 11010 Reames Road
 Charlotte, NC 28269

Deficiency	Qty	Emergency	Remedial
Caulk application	100 LF	\$500.00	
Caulk application	2 EA	\$20.00	
Rooftop projections are rusting	1 EA	\$50.00	
Total		\$570.00	\$0.00
Main office Total: \$570.00

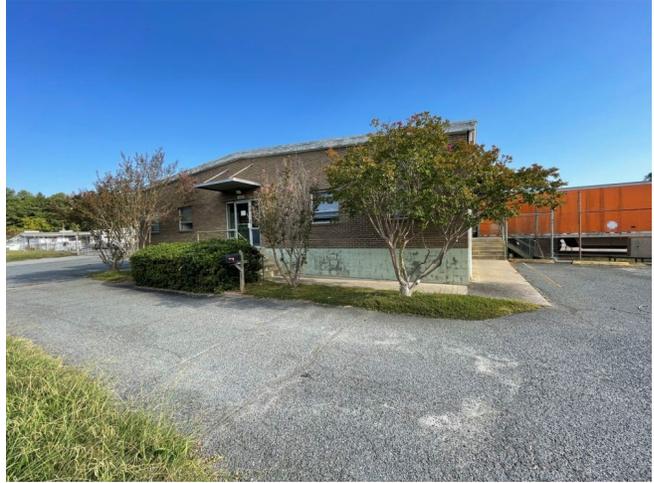
Estes-Durham, NC
 3215 US HWY 70
 Durham,, NC 27703

Deficiency	Qty	Emergency	Remedial
MB Base flashing coating (Aluminum)	7 EA	\$1,200.00	
Total		\$0.00	\$0.00
Section 1 Total: \$1,200.00

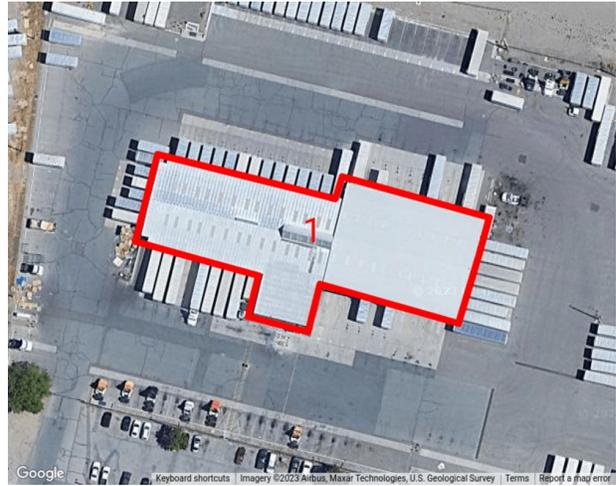
YRC Inc. Reno, NV
 1650 Kleppe Lane
 Reno, NV 89431

Deficiency	Qty	Emergency	Remedial
Debris	550 LF		\$1,600.00
Missing Fasteners on metal roofs	250 EA	\$2,275.00	
Pipe penetration failure	17 EA	\$1,445.00	
Fastener Backing Out	10250 EA	\$7,500.00	
Safety - Missing Skylight Screens	48 EA	\$39,200.00	
Gutter/downspout replacement	180 LF	\$2,820.00	
Total		\$53,240.00	\$1,600.00
Main Total: \$54,840.00
