**IN THE UNITED STATES BANKRUPTCY COURT
FOR THE DISTRICT OF DELAWARE**

**OBJECTION AND RESERVATION OF RIGHTS
TO THE DEBTORS' NOTICE OF POTENTIAL ASSUMPTION OR
ASSUMPTION AND ASSIGNMENT OF CERTAIN CONTRACTS
OR LEASES ASSOCIATED WITH THE NON-ROLLING STOCK ASSETS**

MANAGEMENT REPORT

YRC Inc. Kearny, NJ
72 Second Street
Kearny, NJ 07032

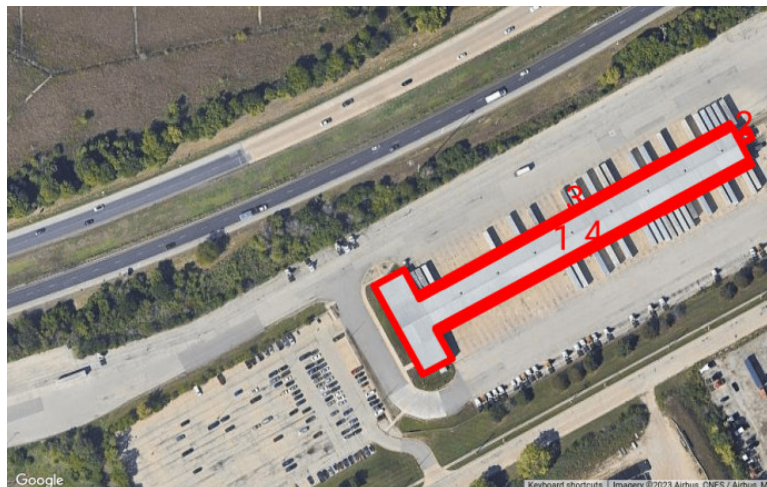
SECTION: Section I - Main Roof

Deficiency	Qty	Emergency	Remedial
Fastener Backing Out	300 EA	\$1,530.00	
Caulk application	20 EA	\$1,020.00	
Missing Fasteners on metal roofs	25 EA	\$128.00	
Pipe penetration failure	3 EA	\$1,530.00	
Gutter straps rusted	60 EA		\$1,510.00
Detached Panels	3 EA		\$0.00
Debris	200 LF	\$310.00	
Mobilization	1 EA	\$620.00	
Improper Repairs	12 EA	\$7,440.00	
Total		\$12,578.00	\$1,510.00
Section 1 - Main Roof Total: \$14,088.00

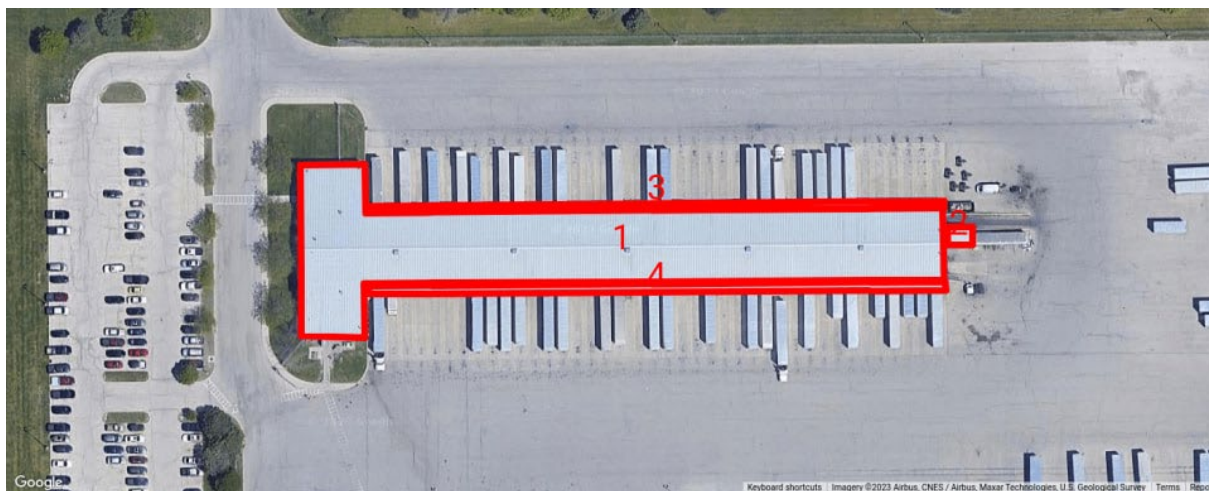
SECTION: Section 1 - Main Roof

Deficiency	Qty	Emergency	Remedial
Caulk application	3 EA	\$156.00	
Fastener Backing Out	350 EA	\$1,785.00	
Debris	200 EA	\$310.00	
Rust	25 EA		\$1,750.00
Pipe penetration failure	8 EA	\$4,080.00	
Mobilization	1 EA	\$710.00	
Total		\$7,041.00	\$1,750.00
Section 1 - Main Roof Total: \$8,791.00

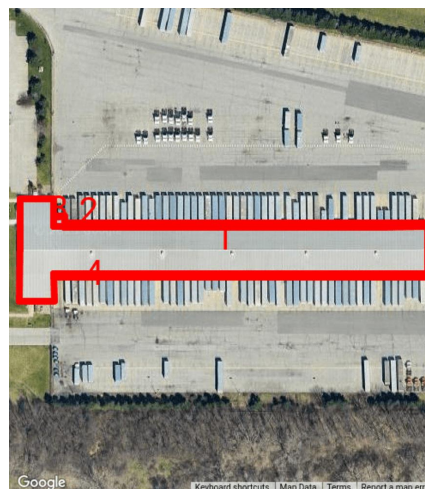
SECTION: Main section

Deficiency	Qty	Emergency	Remedial
Debris	50 LF		\$500.00
Total		\$0.00	\$500.00
Main section Total: \$500.00

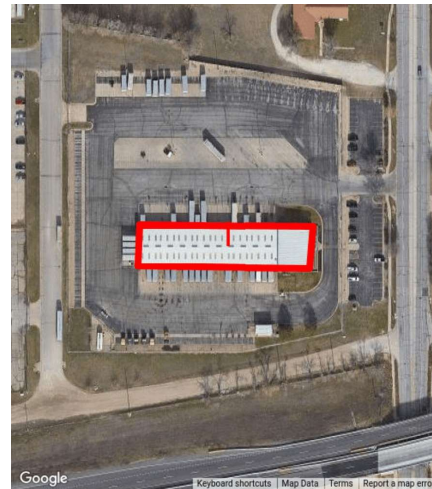
SECTION: Section I

Deficiency	Qty	Emergency	Remedial
Fastener Backing Out *	30 EA	\$1,095.00	
Fastener Failure	180 EA	\$2,250.00	
Vent pipe flashing	8 EA	\$1,075.00	
Caulk application	13 LF	\$0.00	
Fastener Backing Out	27 EA	\$0.00	
Caulk application *	30 EA	\$1,055.00	
Field-Punctures, cracks, splits	9 EA	\$1,175.00	
Caulk application	10 LF	\$0.00	
Total		\$6,650.00	\$0.00
Section 1 Total: \$6,650.00

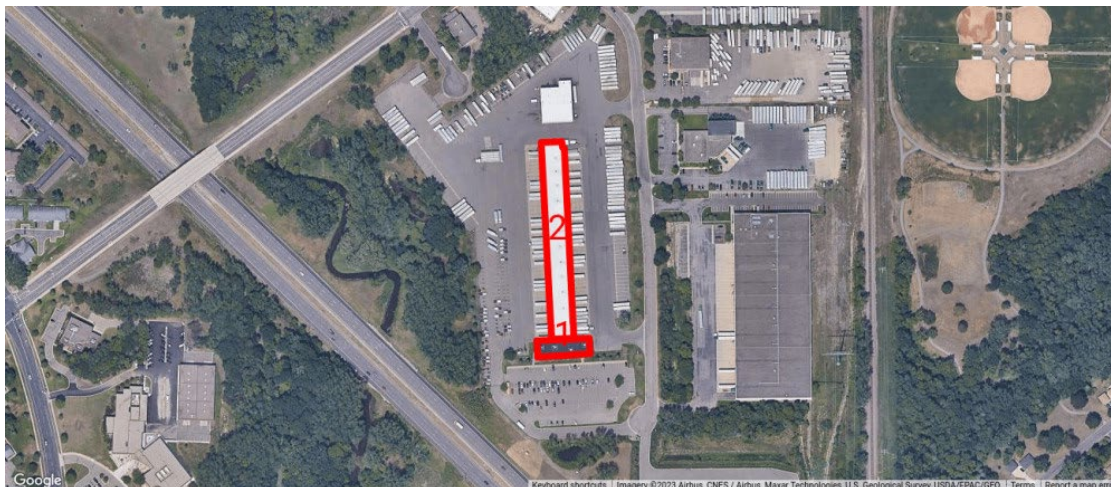
SECTION: I-Office

Deficiency	Qty	Emergency	Remedial
Fastener Backing Out	2 EA	\$220.00	
Rooftop projections are rusting	1 EA	\$450.00	
Insulation replacement	100 SF	\$750.00	
Safety - Roof Hatch Safety Rail	1 EA	\$5,020.00	
Total		\$6,440.00	\$0.00
1-Office Total: \$6,440.00

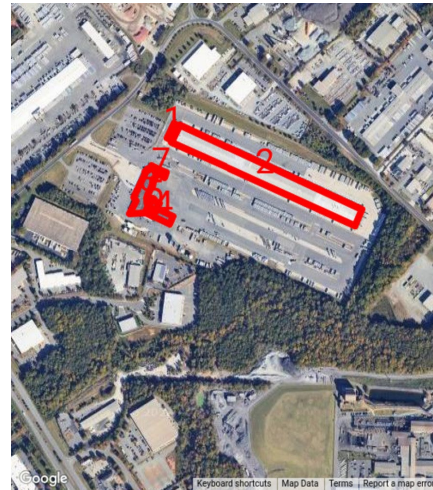
SECTION: Main office

Deficiency	Qty	Emergency	Remedial
Caulk application	100 LF	\$500.00	
Caulk application	2 EA	\$20.00	
Rooftop projections are rusting	1 EA	\$50.00	
Total		\$570.00	\$0.00
Main office Total: \$570.00

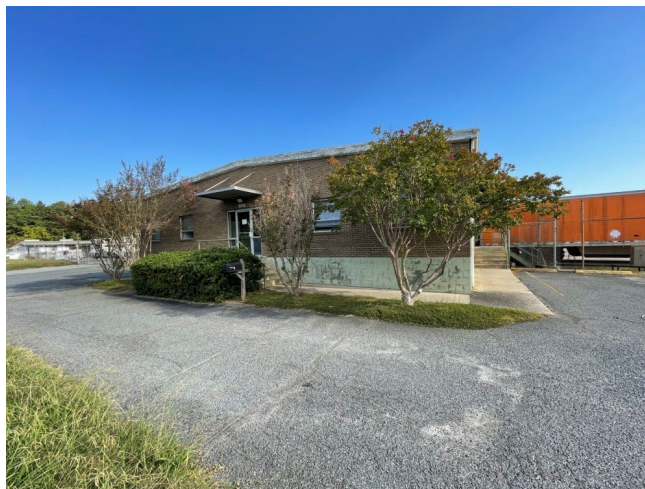
SECTION: Section I

Deficiency	Qty	Emergency	Remedial
MB Base flashing coating (Aluminum)	7 EA	\$1,200.00	
Total		\$0.00	\$0.00
Section 1 Total: \$1,200.00

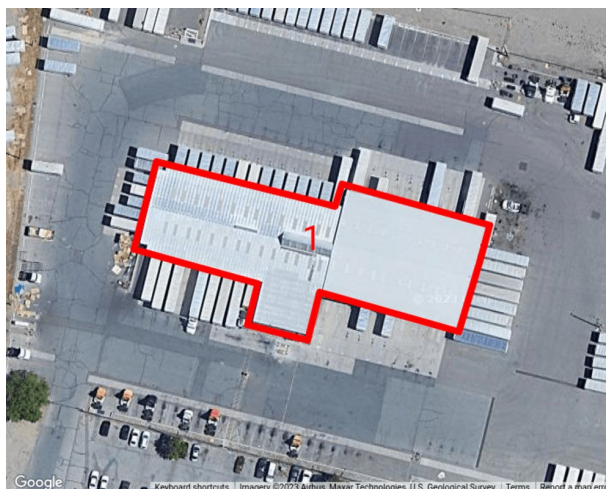
SECTION: Main

Deficiency	Qty	Emergency	Remedial
Debris	550 LF		\$1,600.00
Missing Fasteners on metal roofs	250 EA	\$2,275.00	
Pipe penetration failure	17 EA	\$1,445.00	
Fastener Backing Out	10250 EA	\$7,500.00	
Safety - Missing Skylight Screens	48 EA	\$39,200.00	
Gutter/downspout replacement	180 LF	\$2,820.00	
Total		\$53,240.00	\$1,600.00
Main Total: \$54,840.00
